Manhole Inspection Summary

Manhole # S21UU1030MH

Insp Date: **5/9/07 2:35 PM**

Location Address: **CROSS KEYS RD**

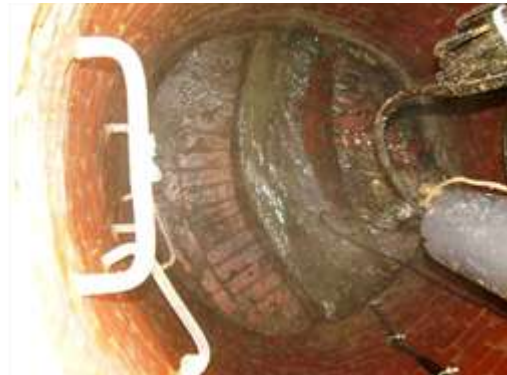
Top View

Evidence of surcharge - Bench debris.

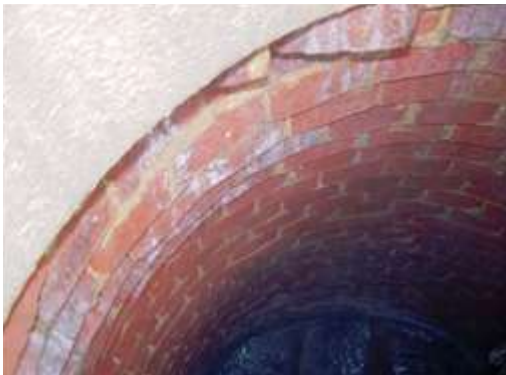
Defect

Frame leaks. Corbel deterioration, loose brick and infiltration. Barrel infiltration.

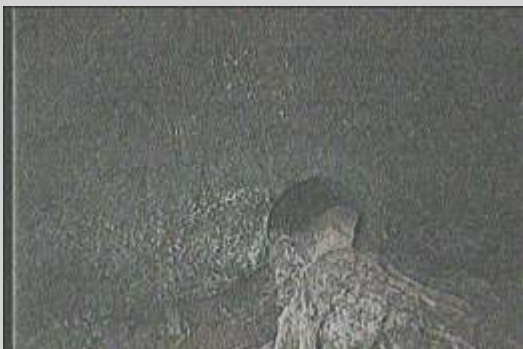
6 in. Circular Gravity Sewer Pipe In @ 3 O'Clock

Deposits: ☐ None ☐ Mud ☐ Sludge ☒ **Debris** ☐ Grease

Silt Depth: **0** (in.) Deposits Extent: **Heavy**
